EAST POND

WATERSHED-BASED MANAGEMENT PLAN

Kennebec County Soil & Water Conservation District
21 Enterprise Drive, Suite #1
Augusta, ME 04330
http://kcswcd.org

Jennifer Jespersen Ecological Instincts Manchester, ME 04351 P.O. Box 682

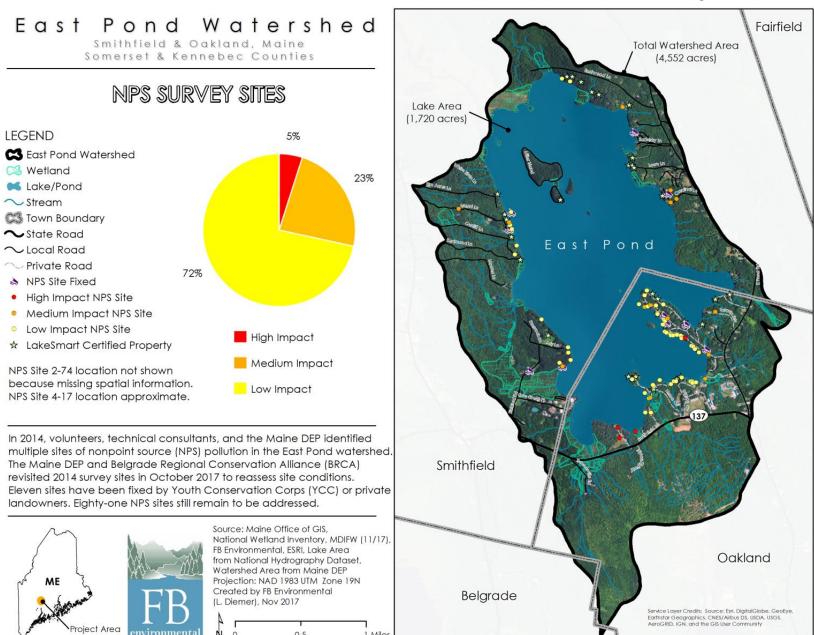
Figure 1. Location of documented watershed survey sites, completed YCC projects, and certified LakeSmart properties in the East Pond Watershed.

East Pond has been the recipient of three past 319 implementation projects between 1999 and 2012 that addressed 64 NPS sites, and resulted in a reduction of the external phosphorus load to East Pond on the order of 31 pounds of phosphorus annually.⁴ The BRCA is in the process of planning for a Phase IV implementation project following announcement of a conditional grant award from the US EPA to conduct an alum treatment on East Pond. The project is expected to begin in the spring of 2018.

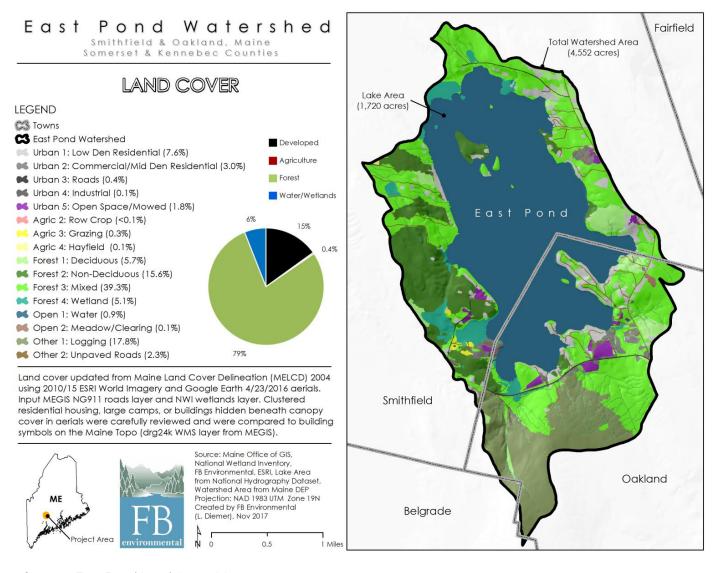
Figure 3. East Pond Land Cover Map.

An analysis of land cover in the watershed indicates that the majority of the non-lake watershed is forested (79%), consisting mostly of mixed forest, followed by developed land (15%), wetlands (6%)⁹, and agriculture (<1%) (Figure 3). Logging accounts for approximately 18% of the forested area, equivalent to 487 acres. Low density residential development accounts for the largest percentage of the developed urban land cover category at 7.6%.

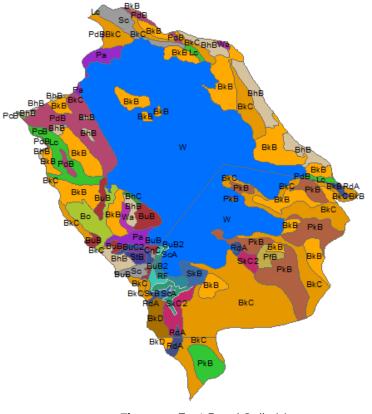
Figure 4. East Pond Soils Map.

A previous assessment of East Pond soils looked at the potential erodibility of soils in the watershed, and found that soils in the immediate shoreline area (~150 ft) are, for the most part, highly erodible (Table 3A); whereas soils in the uplands are mostly not highly erodible (Table 3B). Areas of potentially highly erodible soils should be further assessed prior to development based on slope and the proposed development to ensure development is compatible with the proposed use.

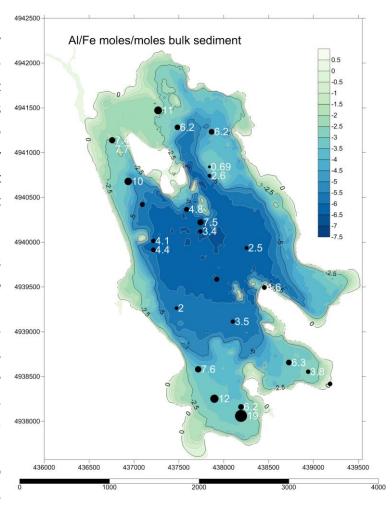
Figure 5. Al:Fe ratios in East Pond bottom sediments. *Source: Colby College.*

A 2017 analysis of East Pond's sediments examined the geochemistry to determine the total iron and aluminum concentrations and available phosphorus in the sediment. The 4939000 analysis required collecting numerous sediment samples (1 cm and 10 core samples) at 23 locations between 2015-2017. Extracted iron, aluminum, and phosphorus were compared in units of µmol element/g sediment. The purpose of the study was to determine Al:Fe ratios to inform scientists about the dosing needed for a successful alum treatment. Al:Fe ratios below five conditions where reductive create

dissolution of Fe(III) can release significant amounts of Fe-bound phosphorus to the bottom water of the lake, resulting in internal phosphorus loading that results in algal blooms. Results of this analysis show that significant areas of East Pond, especially in the deepest areas of the lake, have Al:Fe ratios below this threshold (Figure 5) (King, 2017b). Increasing the concentration of aluminum in the bottom sediments will help bind phosphorus at the bottom of the lake and prevent its release into the water column.

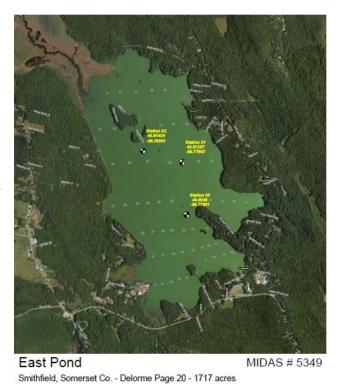
Figure 7. Water quality monitoring stations in East Pond (LakesofMaine.org).

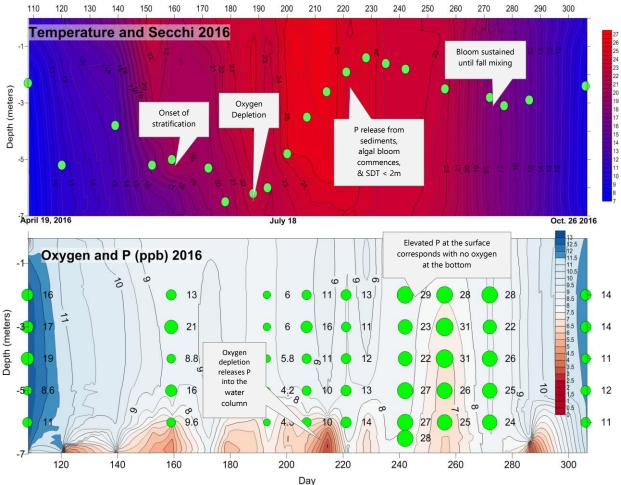
Figure 8. Temperature and Secchi profile with Oxygen and Phosphorus at East Pond Station 1 in 2016 (Source: Colby College).

Monitoring data shows that East Pond experiences predictable nuisance algal blooms that begin between July and September each year. These blooms result in diminished water clarity (SDT <2m) and loss of recreational opportunities. This annual pattern was confirmed by the recent data collected by Colby College which shows that changes in water quality are triggered by short-lived periods of stratification followed by anoxic conditions (no oxygen) 1 m above the sediment (Figure 8).

which result in Secchi measurements between 1 and 3 m that continue to stay low until fall mixing when average phosphorus concentrations fall back to around 12 ppb. Figure 8 (top) shows the relationship between temperature and SDT in East Pond. East Pond remained mixed (purple areas) until stratification set in around day 155 through 170, and 200.

Each of these short-lived stratifications created anoxic conditions 1 m above the sediment, followed by a mixing event (Figure 8, bottom). The final mixing event around day 230 released phosphorus from the sediment into the water column at average concentrations > 26 ppb that continued through fall mixing when average phosphorus concentrations fell to 12 ppb.

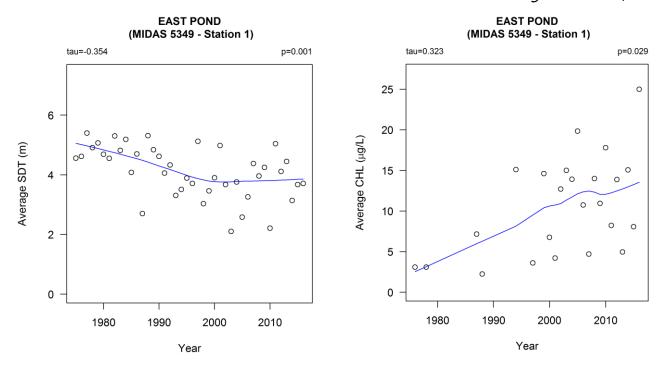
Figure 9A & 9B. Trend plots of long-term SDT (left) and Chl-a data (right) for East Pond, Station 1, with results of Mann-Kendall Trend Tests (Source: Maine DEP).

A statistical analysis was conducted by Maine DEP to determine whether the water clarity in East Pond has changed over time. Both short (2007-2016), and long-term (1975-2016) trends were examined. Results of the Mann-Kendall trend tests indicate a significant downward trend in average

SDT (lower water clarity over time) (Figure 9A), as well as a significant increase in Chl-a (increasing algal density) over the historical sampling period (Figure 9B). The blue line is a lowess (locally weighted scatter plot smoothing) curve. Significance of the SDT results may be influenced by a higher number of lower readings in recent years, timing of sampling and density of samples in a given year. Figure 9b shows the variability in the data (large spread). No significant results were indicated for total phosphorus (short or long-term), indicating that phosphorus levels have remained stable over the historical sampling period. Similarly, the short-term SDT data suggests a stable trend in clarity (Figure 10).

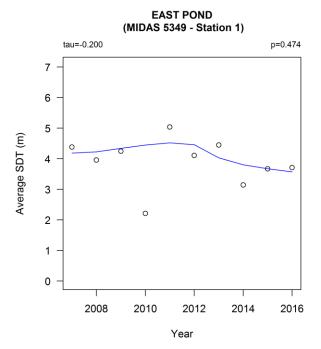
Figure 10. A Mann-Kendall trend test showing lack of significant change in the mean annual SDT data over the past ten years (Source: Maine DEP).

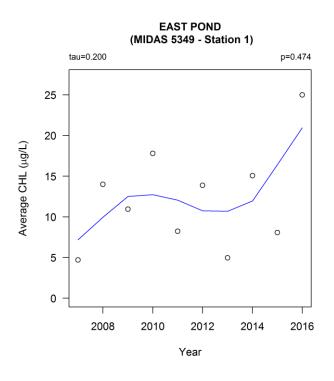
Figure 11. A Mann-Kendall trend test using Chl-a data collected in East Pond over the past 10-years showing alternating high/low pattern in the annual mean. (Source: Maine DEP).

One interesting result of this analysis is the short-term Chl-a results (Figure 11). While not significant statistically, the data show a pattern of alternately high and low annual means, repeated from year to year over the 10-year period. A more in-depth look at the data is needed to better understand this trend. This may include looking at when the samples were collected, how many samples were collected, and what the length of the bloom period was. Table 1 may shed some light into this pattern; some years blooms start in early to mid-summer and last through September (higher average Chl-a) vs. other years where blooms don't begin until late summer or early fall (fewer high readings over the sampling season).

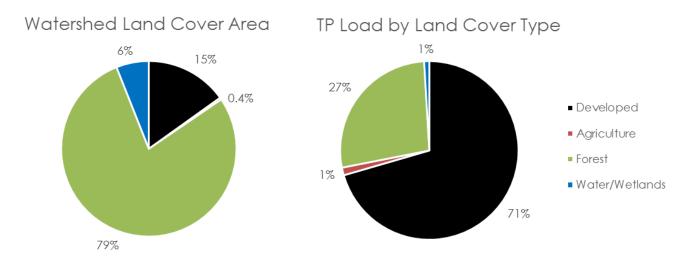
Figure 12. Watershed land cover area by general category (developed, agriculture, forest, and water/wetlands) and total phosphorus (TP) load by general land cover type.

While the percent of developed land in the watershed may seem inconsequential compared to the watershed area as a whole, numerous scientific studies have shown that the more developed a watershed is, the more impact there is on the water quality of lakes and streams due to pollutants delivered by stormwater runoff. In fact, what may seemingly be a small amount of development can result in a large pollutant load. In the case of East Pond, the developed area of 15% results in 71% of the watershed's total phosphorus (TP) load; a fraction of the TP load from the other land cover types (Figure 12).

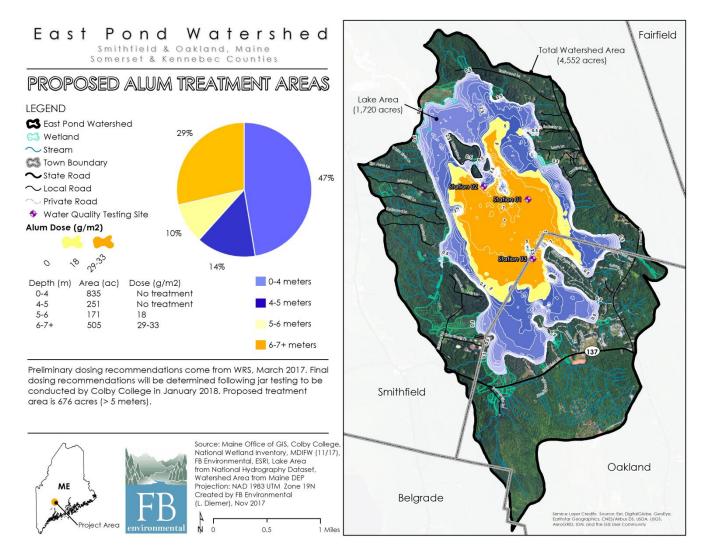
Figure 13. Proposed alum treatment areas and dosage for East Pond.

The area of the lake to be treated and the treatment dose are subject to additional lab investigations. Colby will be leading lab assays (jar testing) with support from Maine DEP and WRS using sediment collected from the bottom of East Pond. Results of these tests will determine the overall area to be treated and aluminum doses, as well as final costs to complete the treatment. Current management recommendations (pre-jar testing) include treating all areas in East Pond deeper than 5 m with a dose of aluminum between 18 - 33 g/m2, though dosing may vary based on depth intervals. This is an area of approximately 676 acres (Figure 13), and is estimated to cost between \$800,000 - \$900,000 for a one time treatment. Monitoring will be conducted before, during and after the alum treatment.

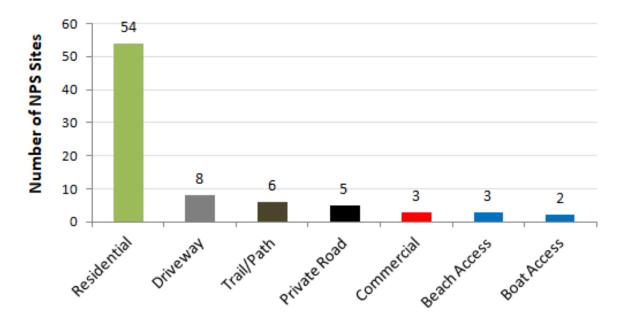
Figure 14. Number of NPS sites in the East Pond Watershed by land-use type (Updated October 2017).

A follow-up to the 2014 East Pond Watershed survey determined that of the original 102 sites surveyed, only 81 still need to be fixed.²¹ Ten of the original sites have been addressed through YCC or LakeSmart projects including one by the Town of Smithfield, and ten were found to have no impact (lack of buffer but no active erosion).

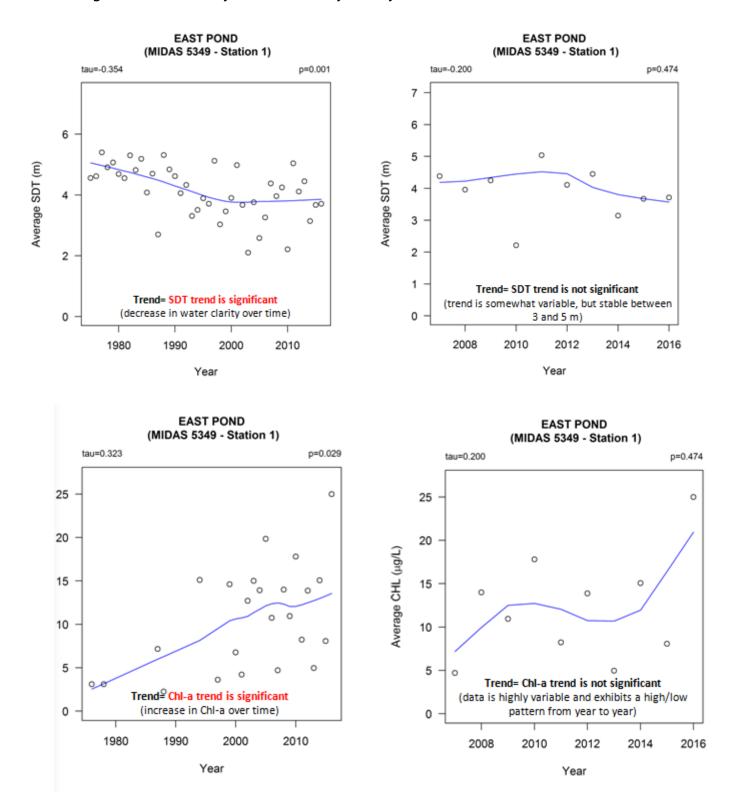
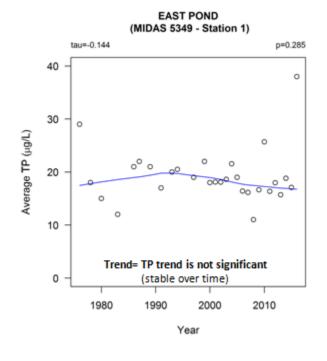
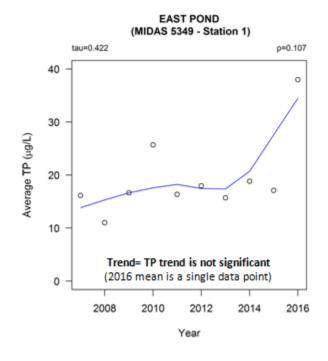
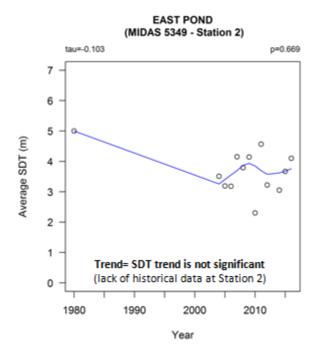
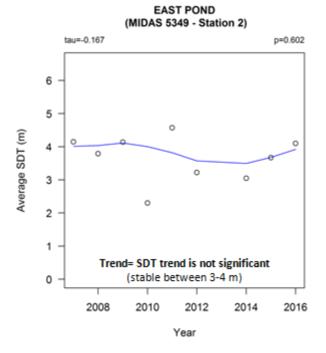
APPENDIX C. Water Quality Trends for East Pond.

Data range 1975-2016. Analysis conducted by Jeremy Deeds, Maine DEP in November 2017.
