# MESSALONSKEE LAKE (SNOW POND)

## WATERSHED-BASED PROTECTION PLAN

(2022-2032)

**MARCH 2022**

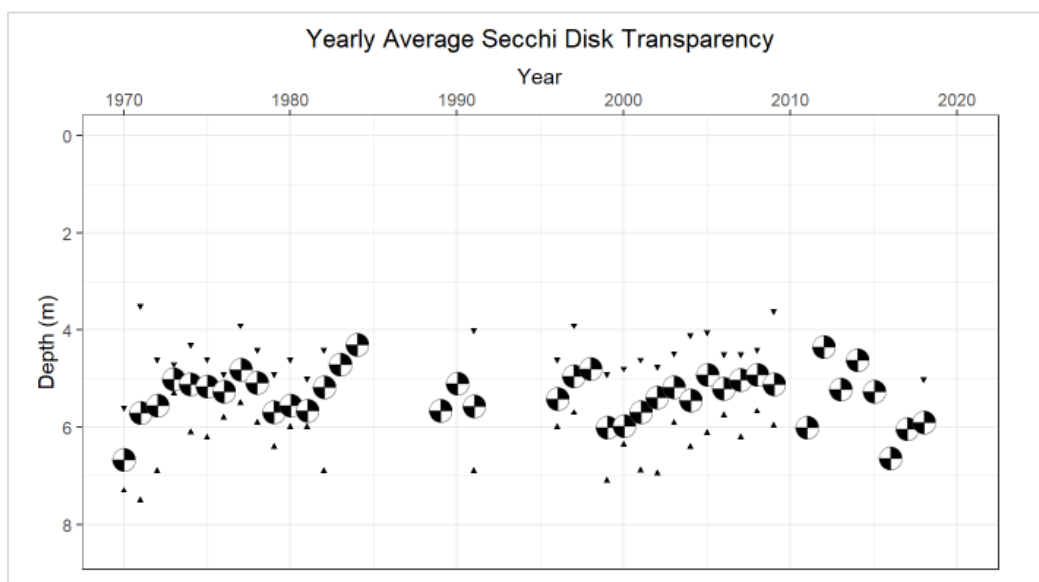
**Figure 4. Average annual water clarity data for Messalonskee Lake (Station 1). (Source: LakesofMaine.org)**

Figure 4 (below) shows the annual average water clarity for Messalonskee Lake at Station 1. Variability in water clarity measurements over time may be influenced by weather (e.g., annual fluctuations in rain/snow), or land-use changes in the watershed (e.g., period of heavy development or forestry activities or watershed improvements).

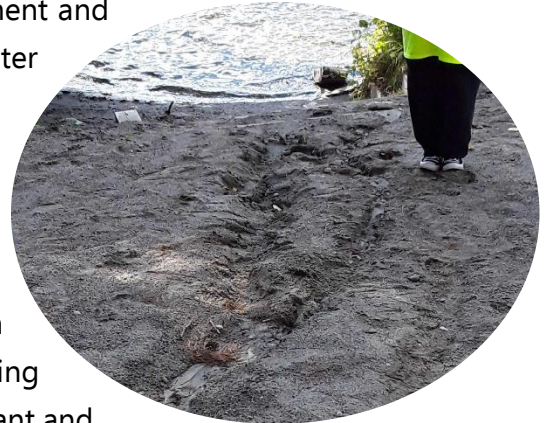
*Soil erosion delivers phosphorus to the lake.*

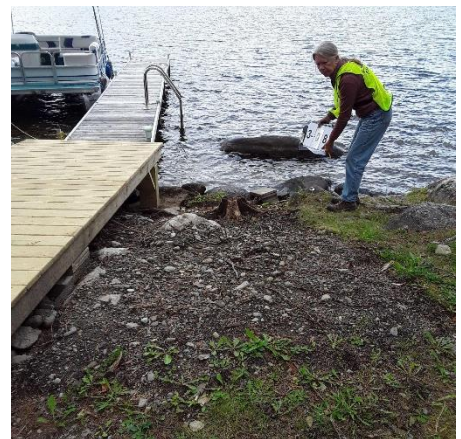
*Lack of shoreline vegetation and bare soil near the shoreline creates erosion problems that allow nutrients and sediments to get to the lake.*

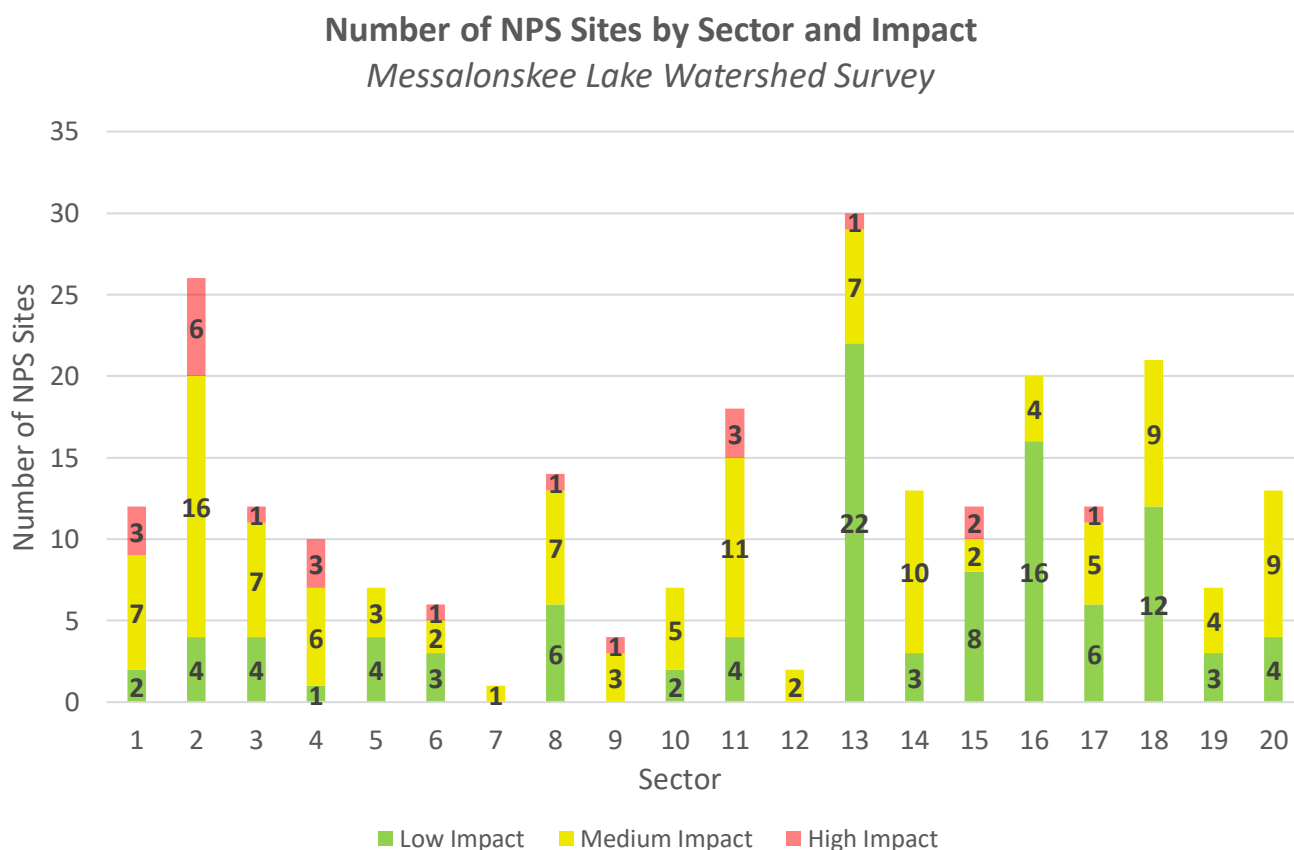
**Figure 8. NPS sites by sector in the Messalonskee Lake watershed.**

The greatest number of sites were documented in residential areas in Sector 13 (western shoreline), followed by Sector 2 (northeast shore), and Sectors 16 and 18 (northwest shore), which all include dense shoreline development. Density of residential development appears to be a primary factor in the number of sites per sector. Despite Sector 13 having the greatest number of sites, it also has the highest number of low-impact sites, whereas Sector 2 has the greatest number of high- and medium-impact sites (Figure 8). Areas with more high- and medium-impact sites should be focused on for improvement because they may be delivering more sediment to the lake, even if they have a lower number of sites.

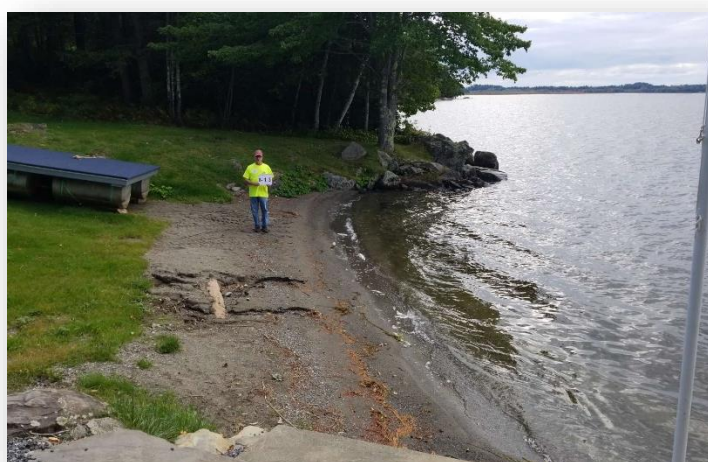
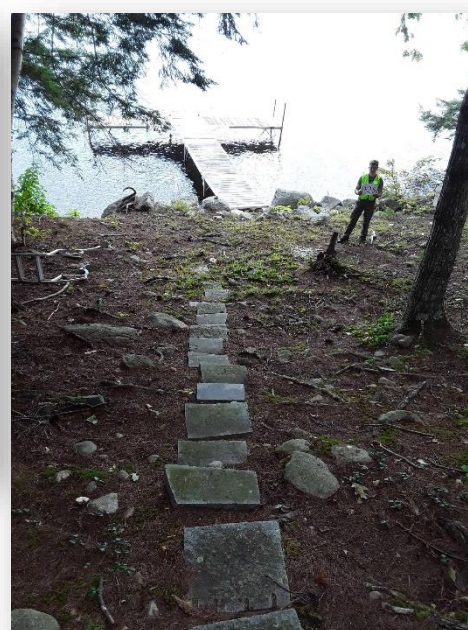
Examples of residential NPS sites: a) Shoreline erosion caused by removal of native vegetation to create a beach on a residential site in Sector 8 (above); and b) an eroding path to the lake in Sector 13 (right).

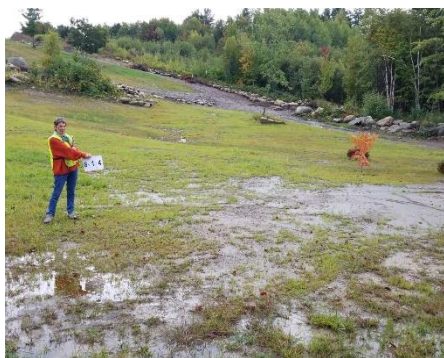
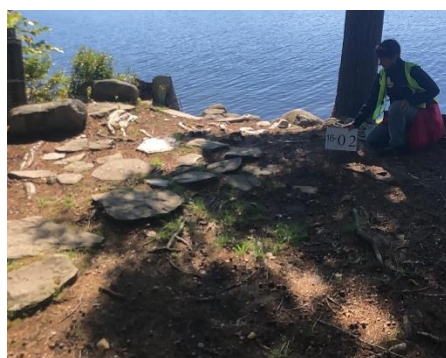
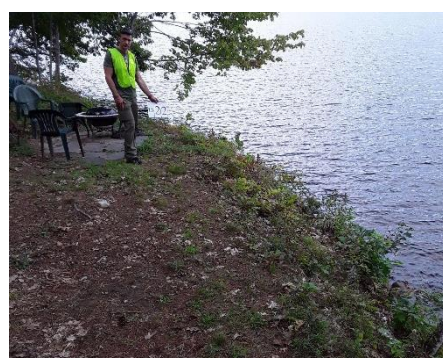
**Medium-impact** sites exhibit sediment transportation off-site, but the erosion does not reach high magnitude.

**High-impact** sites are those with large areas of significant erosion and direct flow to water.

*Examples of residential sites ranked high (left), medium (middle), and low (right) impact.*

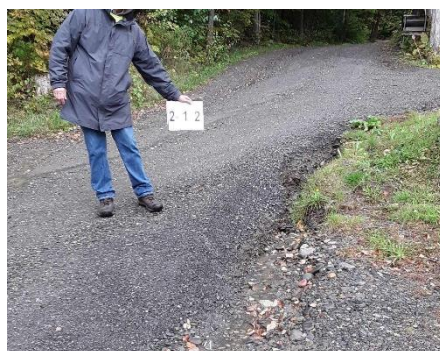
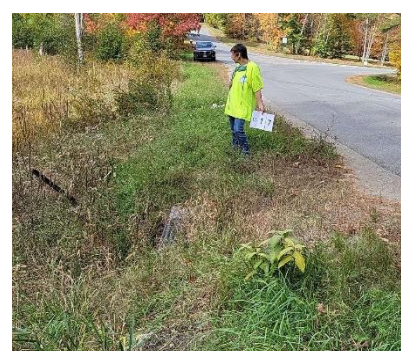
*Examples of road sites ranked high (left), medium (middle), and low (right) impact.*

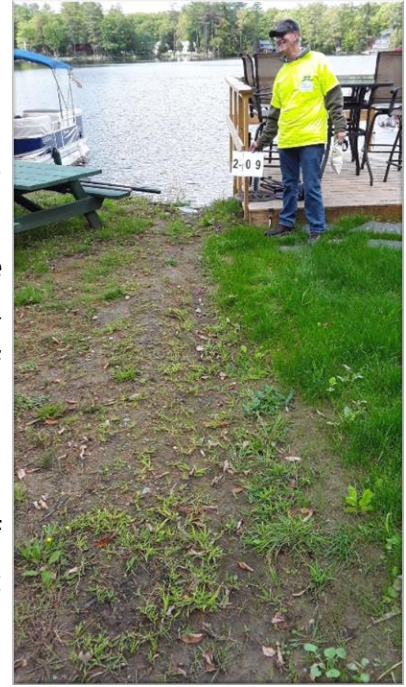
*Example of a medium-impact residential site in Sector 2.*

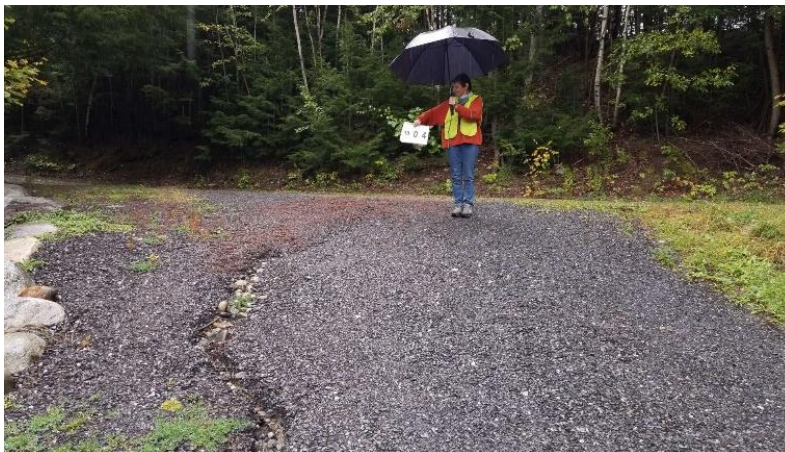
*Example of a medium-impact driveway site in Sector 10.*

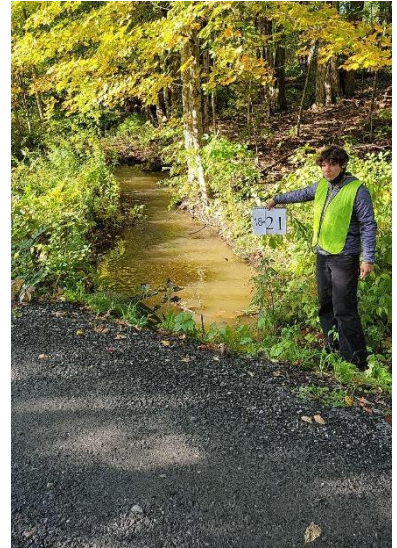
*Example of a medium-impact private-road site in Sector 18.*

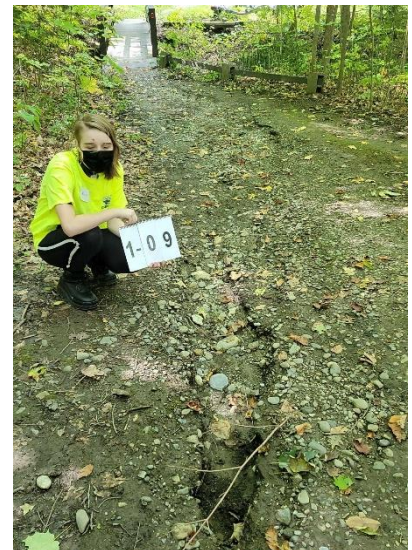
*An eroding trail requires repair to prevent soil erosion from getting to a stream and then into the lake on this high-impact site in Sector 1.*

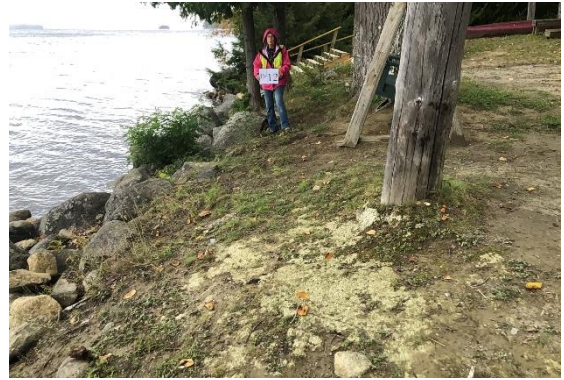
*Lack of shoreline vegetation and a steep slope is causing erosion at this commercial site in Sector 15.*

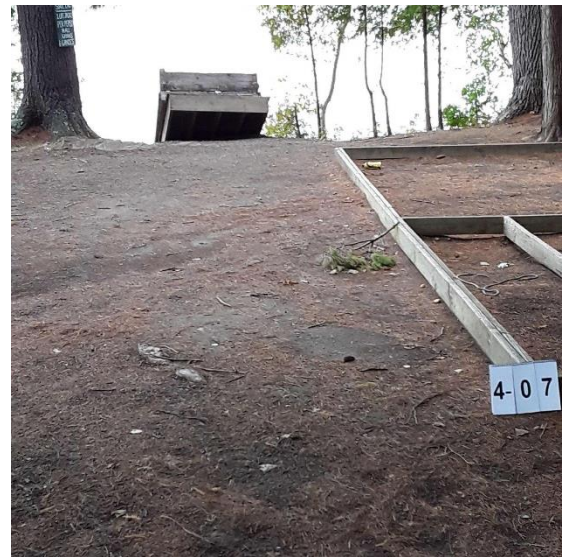
*Example of a medium-impact boat access site in Sector 4.*

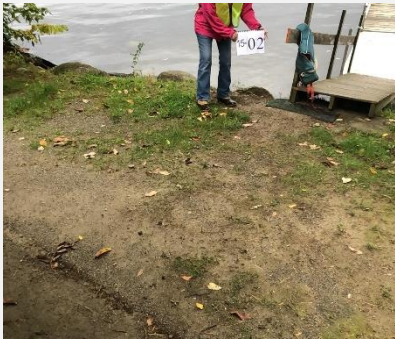
*Sector 13: Site 2*

**Problem:** BARE SOIL, SURFACE EROSION, INADEQUATE SHORELINE VEGETATION

**Solution:** Control runoff from impervious surfaces. Use erosion control mulch in areas with exposed soil, and plant hardy native vegetation along the shoreline to stabilize banks and filter runoff. Consider planting vegetation before using rip rap, or use a combination of both, minimize lawn areas, and add dripline trenches to roof driplines.

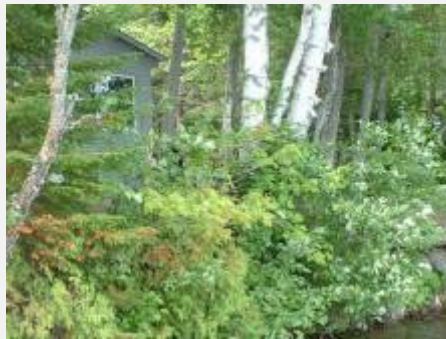
*Vegetated buffers filter out pollutants*

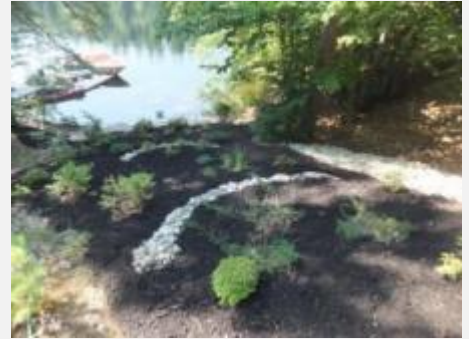
*Erosion control mulch & vegetative planting*

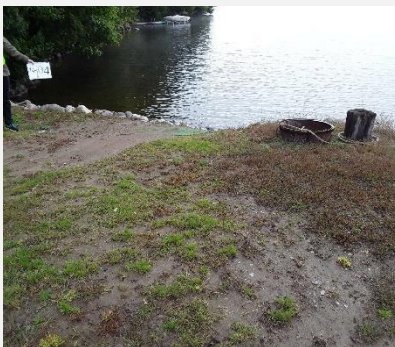
*Sector 14: Site 4*

**Problem:** UNSTABLE BEACH & BOAT ACCESS

**Solution:** Stabilize eroding shorelines by planting a vegetated buffer consisting of a combination of native plants and erosion control mulch or install a rain garden. The roots from these plants will stabilize the shoreline, filter pollutants running off the land, and provide habitat for wildlife. Alternatively, just let the shoreline naturalize by not mowing a wide strip along the shoreline.

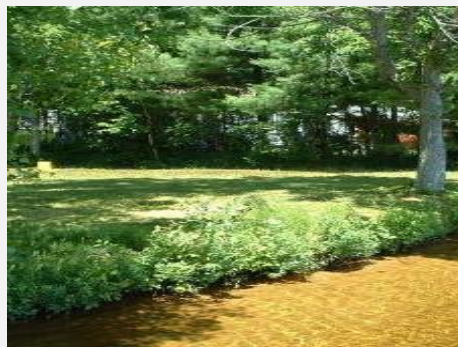
*Allow the shoreline to naturalize by not mowing right to the edge*

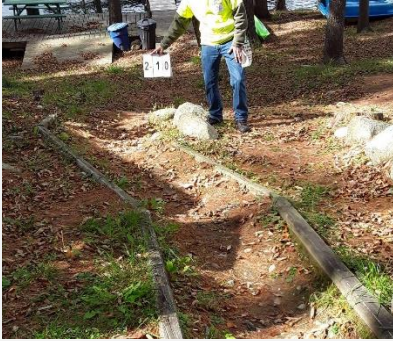
*Sector 2: Site 10*

**Problem:** UNSTABLE TRAILS & PATHS & ERODING ROOF DRIPLINES

**Solution:** Retrofit trails and paths so that they are well defined, narrow (<3 ft), and winding. Install water bars or infiltration steps on steeper slopes to divert or infiltrate runoff and mulch all bare soil areas and install infiltration trenches on roof driplines.

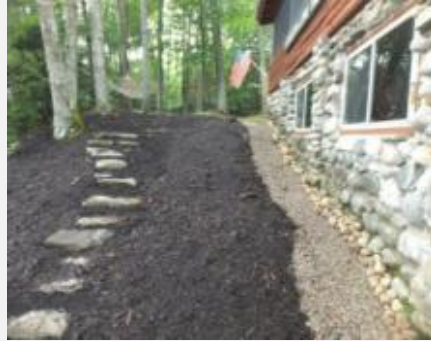
*Dripline trench & erosion control mulch* (Photo: AWWA)

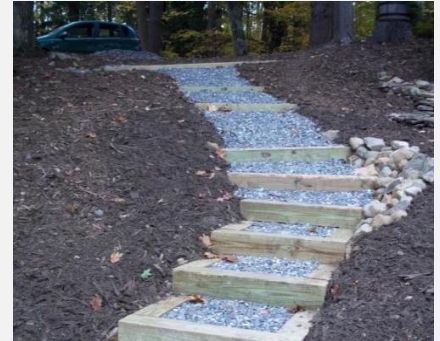
*Infiltration steps protect steep slopes w/foot traffic*

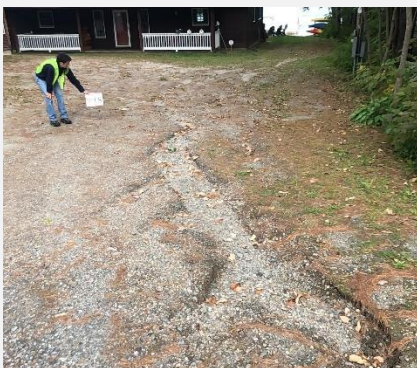
*Sector 5: Site 4*

**Problem:** MODERATE TO SEVERE SURFACE EROSION ON DRIVEWAYS

**Solution:** Re-grade, reshape and/or crown driveways; add new surface material; install runoff diverters such as rubber razors or water bars; maintain and repair existing rubber razors or other driveway runoff diverter annually and after large storm events.

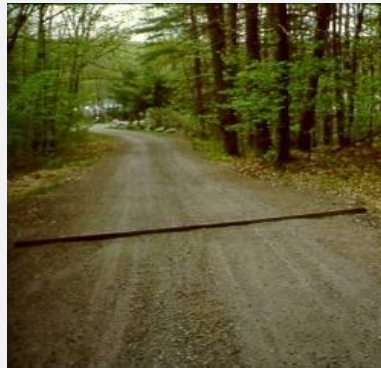
*Rubber razors direct water off driveways and into vegetation*

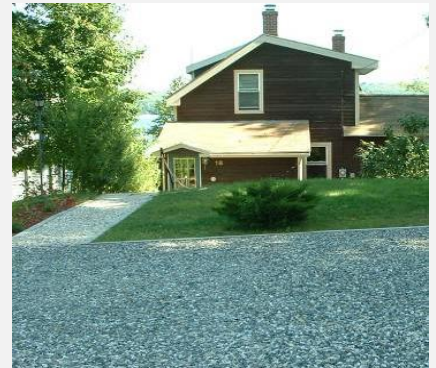
*Resurfacing driveways with hard-packing, cohesive surface material prevents erosion*

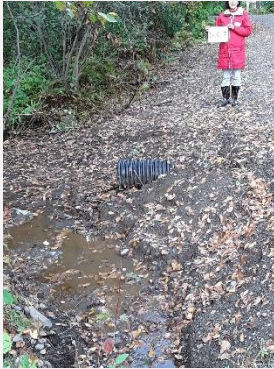
*Sector 5: Site 7*

**Problem:** ROAD EROSION, UNSTABLE OR UNDERSIZED CULVERTS

**Solution:** Reshape and regrade gravel roads, add new surface material, install ditching where needed, and line ditches with rock and vegetate for stability. Replace failing, plugged, crushed or undersized culverts, and stabilize inlets/outlets with rip rap; add runoff diverters; clean up winter sand.

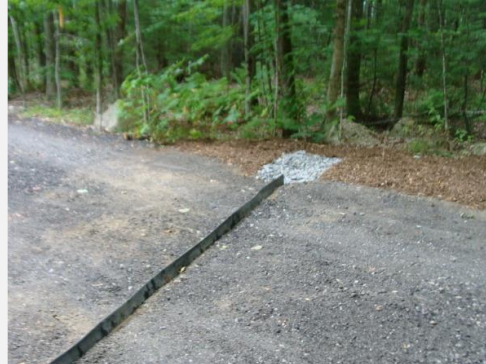
*Reshape gravel roads, add new surface material, and install runoff diverters*

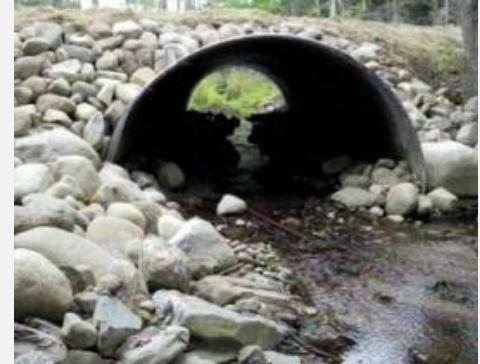
*Replace undersized and perched culverts, remove clogs, armor inlets/outlets and install plunge pools*

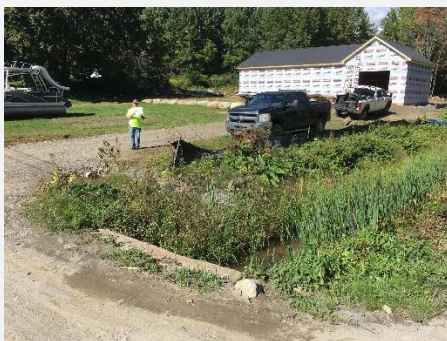
*Sector 8: Site 8*

**Problem:** ROOF RUNOFF EROSION, SURFACE EROSION, BARE SOIL

**Solution:** Install temporary Best Management Practices (BMPs) before construction begins to prevent delivery of sediment to the lake. These may include erosion control mulch berms, hay bales and/or silt fences. Permanent BMPs must be installed following construction to stabilize all bare soil areas. This includes installing a healthy buffer of vegetation along the shoreline and vegetating or mulching all bare soil.

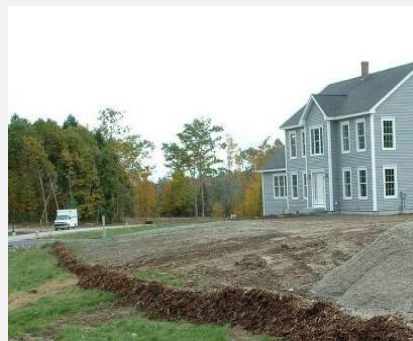
*Install temporary BMPs such as an erosion control mulch berm prior to beginning construction*  
(Photo: Maine DEP)

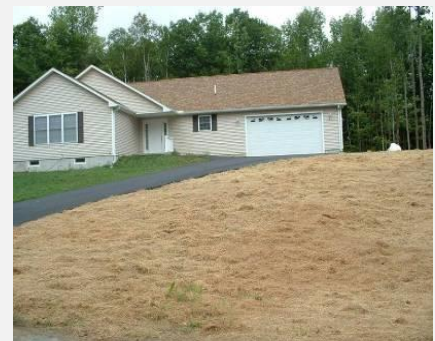
*Install permanent BMPs once construction is complete including seed/ haying bare soil and installing vegetation on the shoreline* (Photo: Maine DEP)

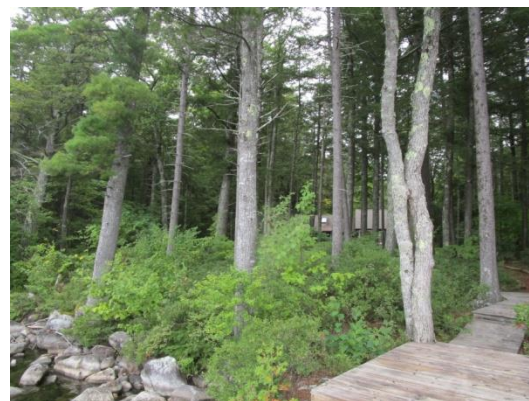
*Example of an excellent shoreline buffer between the lake and the house with multiple types and heights of vegetation.*

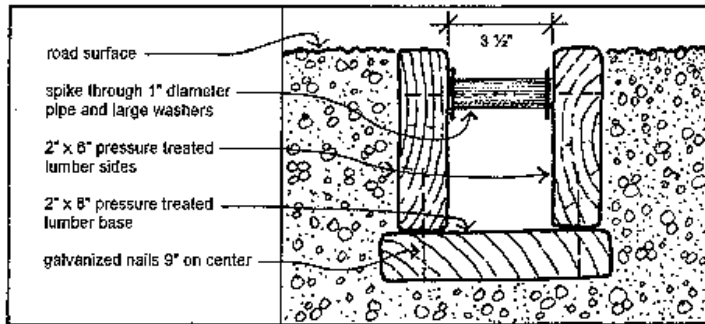
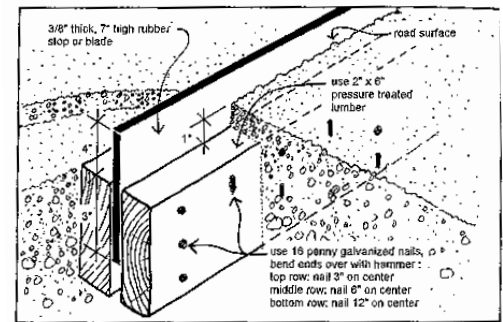
**Rubber Razor Blade:** Use this structure in a gravel driveway or camp road. It can be plowed over only if the plow operator is aware of its presence and lifts the plow blade slightly. Place it at a 30 degree angle to the road edge and direct the outlet toward a stable vegetated area.

**Open Top Culvert:** Use this structure in a gravel driveway or camp road that does not get plowed in the winter. Place it at a 30 degree angle to the road edge and point the outlet into stable vegetation. Remove leaves and debris as needed.
